PHOTOGRAPHIC INTELLIGENCE REPORT

DATE August 1965

CIA/PIR-65024

STATUS OF THE LAO CAI-HANOI AND  
PING HSIANG-HANOI RAILROAD LINES

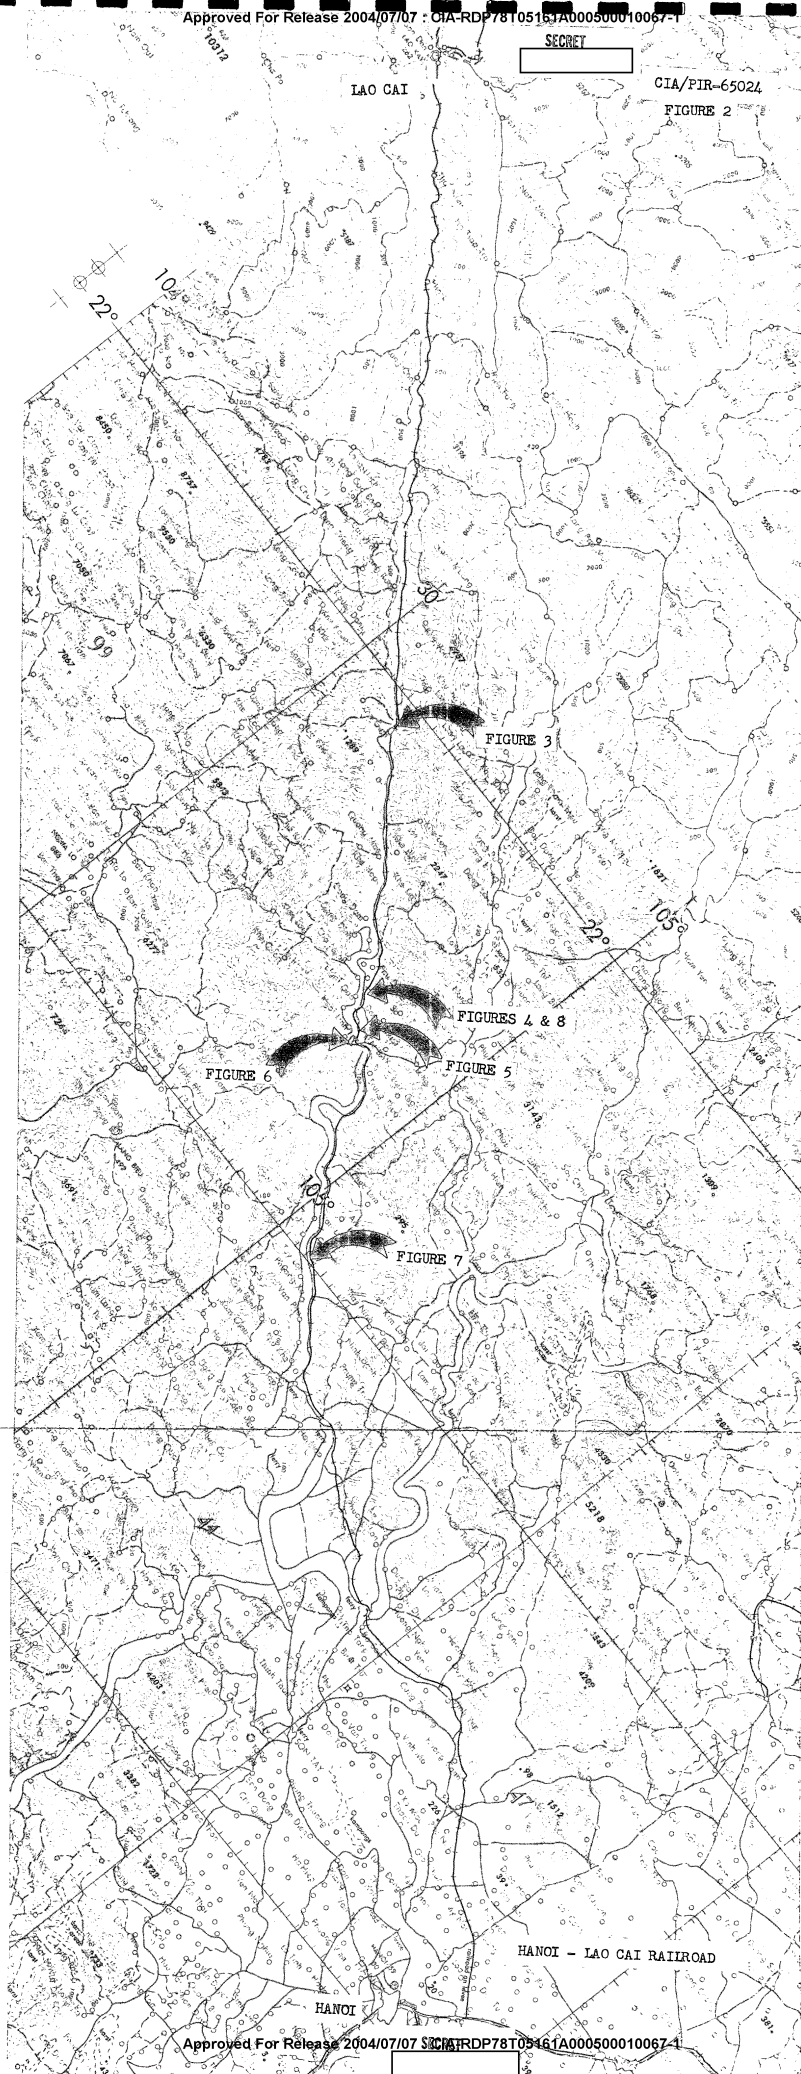
FIGURE 2

LAO CAI

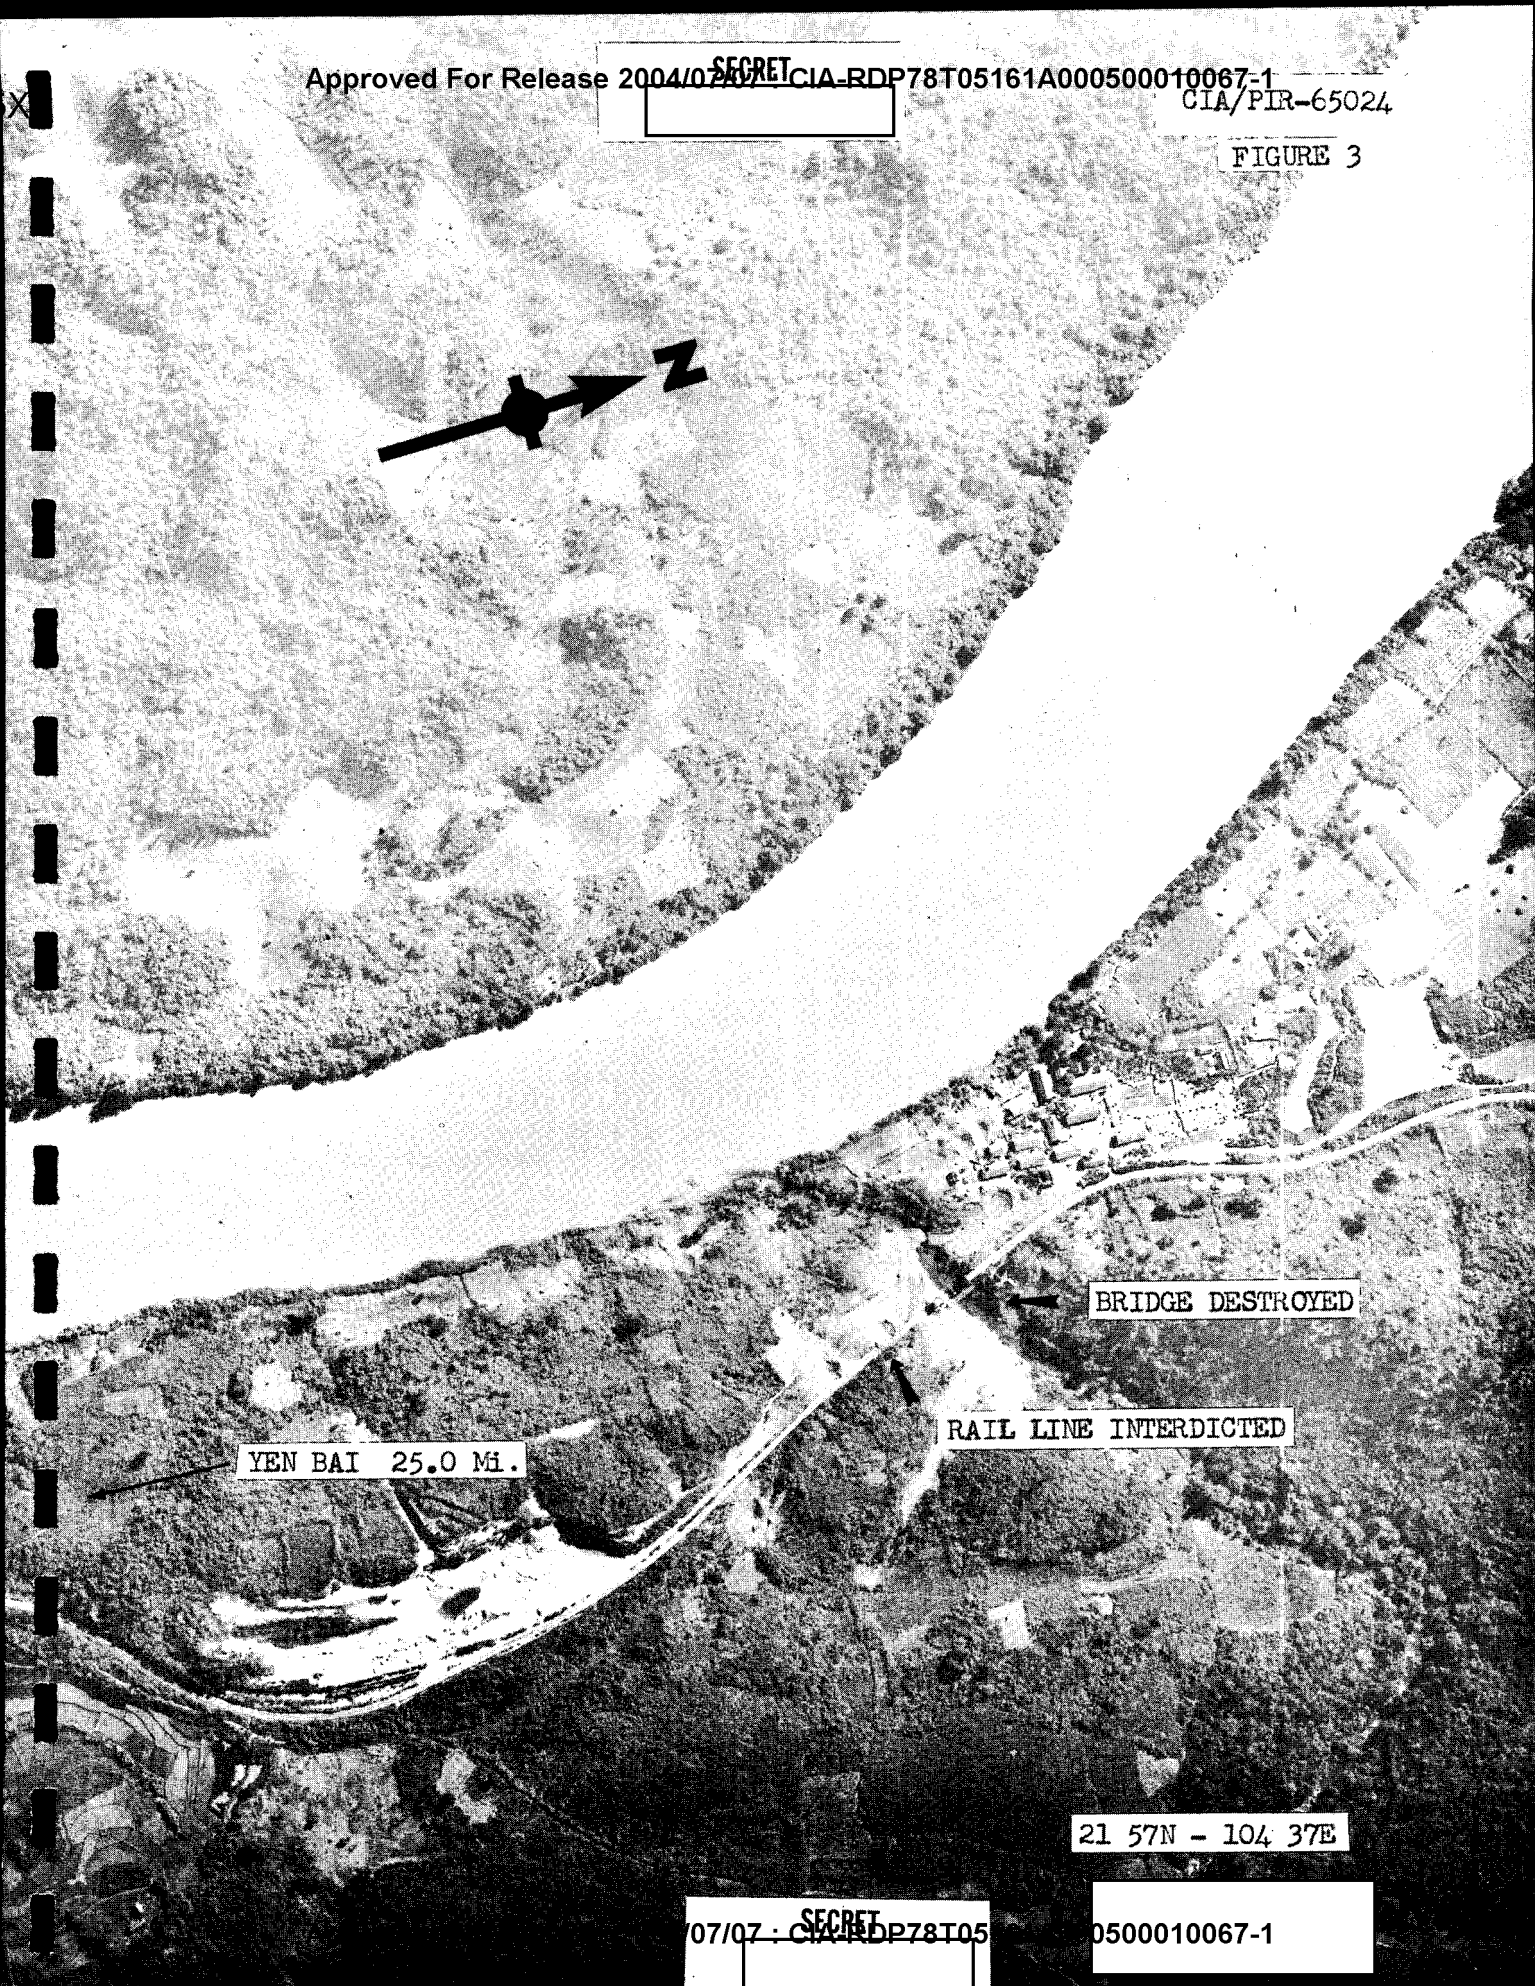
FIGURE 3

YEN BAI 25.0 MI.

BRIDGE DESTROYED

RAIL LINE INTERDICTED

21 57N - 104 37E

<u>LOCATION</u>	<u>DESCRIPTION OF DAMAGE</u>	<u>ATTEMPTED REPAIRS</u>	<u>FIGURE NO.</u>
25.0 Mi. NW of Yen Bai 2157N - 10437E	105 foot half-through truss and deck-girder bridge. Center span and one approach span destroyed, unserviceable. Rail line destroyed for 100 feet south of bridge.	None as of [ ]	3 25
